#### **SWIMMING POOL DECK REPLACEMENT WORKS**

**Title: Penang Swimming Club - Swimming Pool Deck Replacement Memo**

**To:** Development Committee, Penang Swimming Club  
**From:** Ir. Yap Wern Yian  
**Date:** 17 July 2026  
**Ref:** PSC/Swimming Pool Deck/Structural Memo-01  
**Subject:** Condition of Existing Steel Joists Supporting Swimming Pool Composite Timber Deck

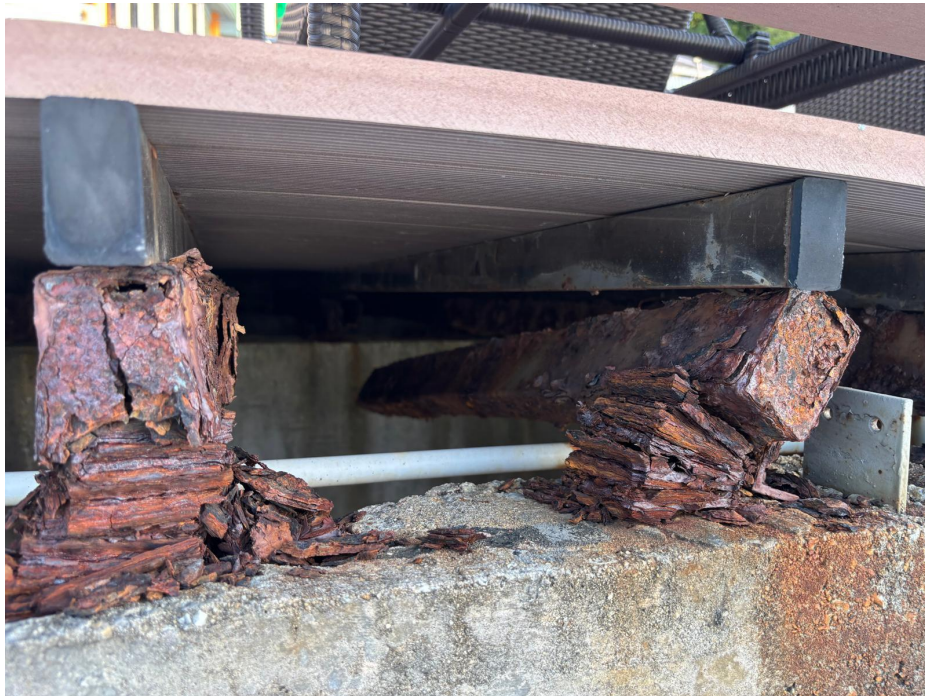
Site inspection has revealed that the existing 125x50x3.0mm thick RHS steel joists supporting the composite timber deck are severely corroded. Section loss is visible at the joist ends and bearing points. As documented in the attached site photograph and proposal drawing.

The corrosion is attributed to the joists' close proximity to the sea and prolonged exposure to a saline, humid marine environment, which has progressively degraded the steel section over time. (**Ref: Figure 1**)

It is the Structural Engineer's opinion that the existing steel joists are unsafe and are no longer capable of reliably supporting the design loads of the composite timber deck. The extent of section loss observed indicates a risk of localised failure if the condition is left unaddressed.

*Figure 1: Current Condition of Timber Deck Steel Joist Onsite*

It is recommended that the corroded steel RHS joists be replaced in their entirety with new hardwood timber joists of Strength Group A, such as Chengal Batu or Balau Kuning, in lieu of steel section. Hardwood timber of this strength group is not susceptible to corrosion and is considered a durable and appropriate replacement for this marine-exposed application.
